Subject: IGNITION DOES NOT TURN OFF WHEN PRESSING START / STOP BUTTON	Bulletin No: 05-004/16
	Last Issued: 04/11/2016

APPLICABLE MODEL(S)/VINS

2013-2014 CX-5 vehicles with VINs lower than JM3KE*****430747 (produced before Dec. 27, 2013)

2014 Mazda6 vehicles with VINs lower than JM1GJ*****162747 (produced before Nov. 29, 2013)

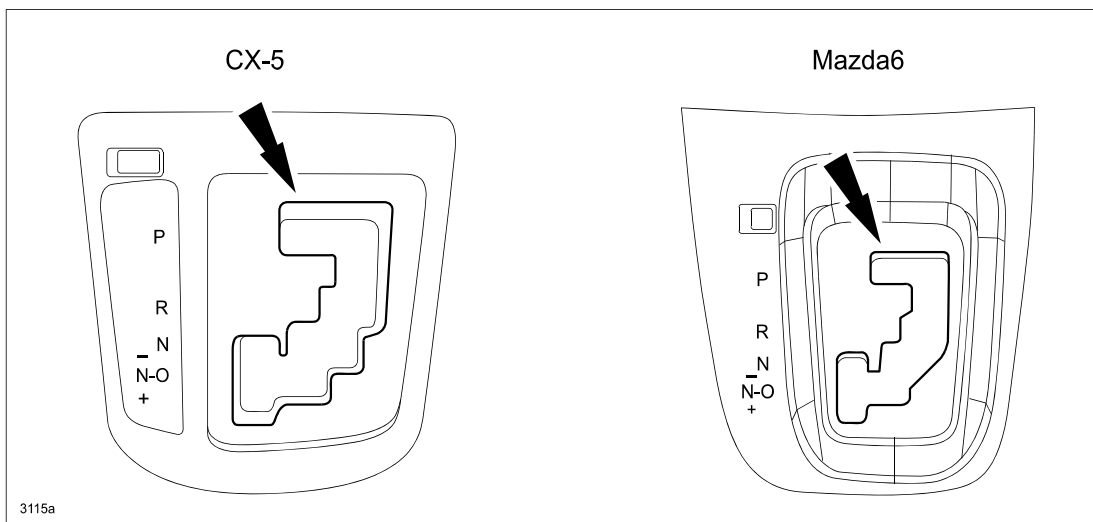
When pressing the START/STOP button, the ignition may not turn off on some vehicles equipped with a gate-type AT shifter. Although the shift lever is in "P" position and the engine shuts off normally, the ignition may stay on (in accessory mode).

This concern may be caused by a worn switch unit. To eliminate this concern, the switch unit material has been changed to improve wear resistance. Modified switch units have been established as new service parts.

Customers having this concern should have their vehicle repaired using the following repair procedure.
