1968 Shelby Lower Valance

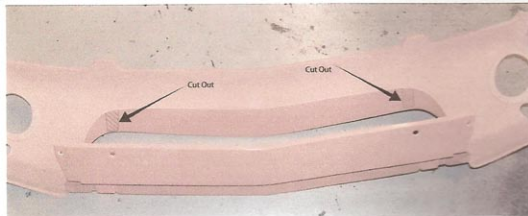
Before

Two cutouts are required before final prep and paint for the clearance of the bumper brackets.

Test fit with brackets installed and mark cutout locations accordingly.
