## 1968 Shelby Lower Valance

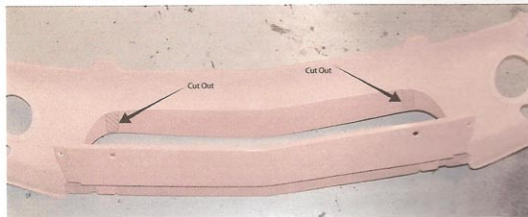
### Before

Two cutouts are required before final prep and paint for the clearance of the bumper brackets.

Test fit with brackets installed and mark cutout locations accordingly.
