NEW ALTERNATOR WIRING UPGRADE CONFIGURATION v.4

— John Hoffman

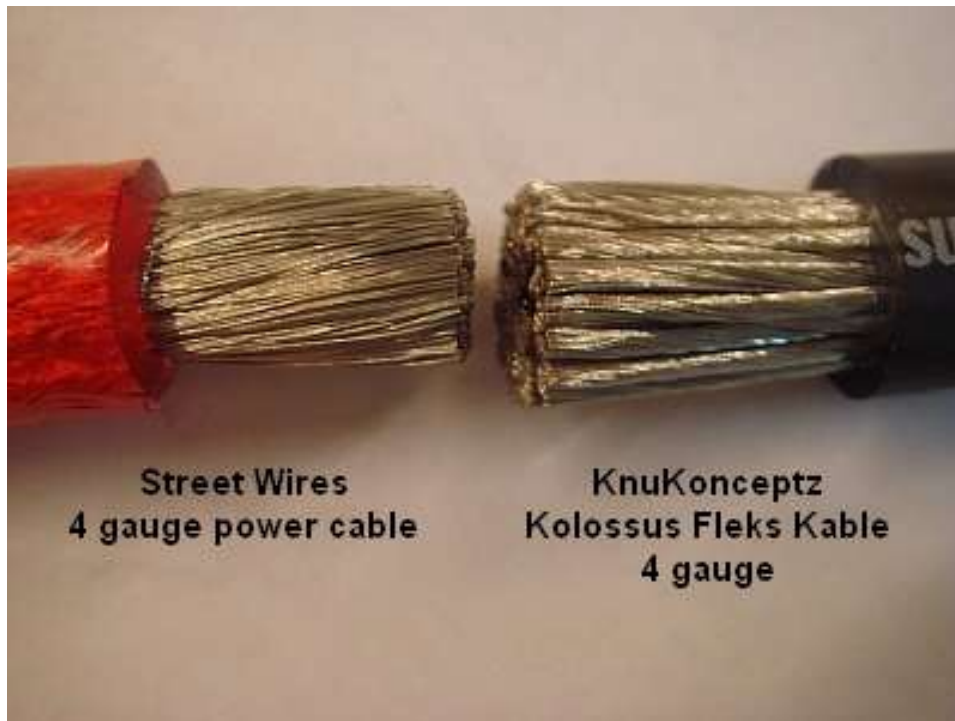
All of the power and ground wire connections in this wiring modification use **4 gauge Kolossus Fleks Kable** by KnuKonceptz (which electrically, is actually closer to 3 gauge) It is 2068 strands of high-density, fine strand, 100% oxygen-free copper that has been tinned to prevent corrosion. It has a great outer sheath and is very flexible. I highly recommend this cable for this particular modification.

As you can see from this photo, there is much more wire in the cable to the right, even though each is the same gauge.

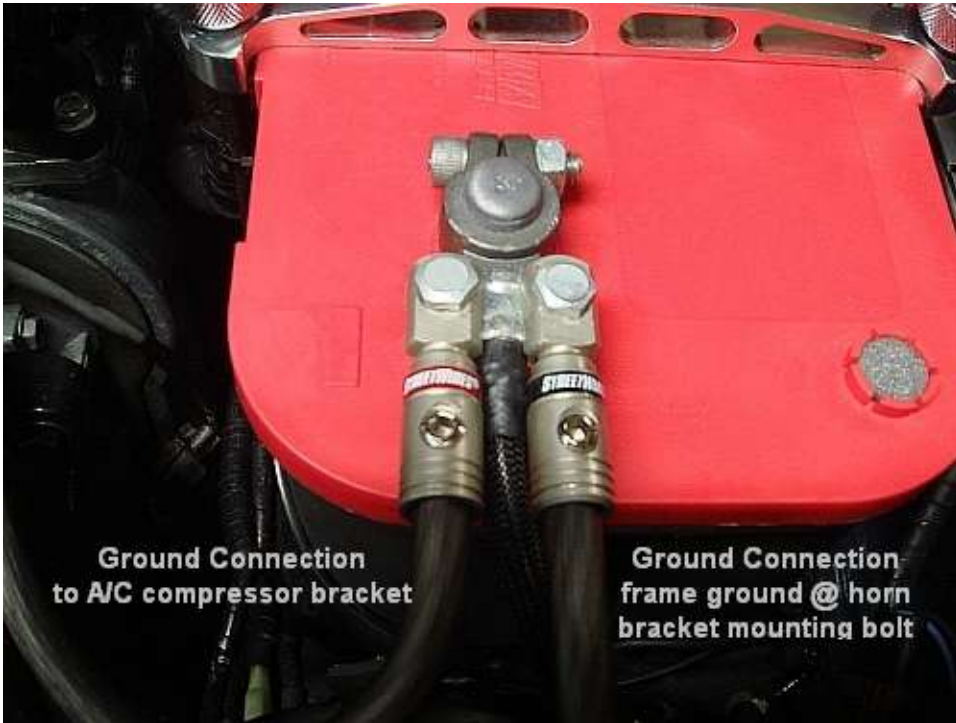
The 4 gauge ground wires from the negative battery terminal to frame ground and engine ground are still being used as in the original configuration, but the smaller, original factory ground wire from the battery to frame ground is now unnecessary and was removed.

In the following photo, the ground cable on the left side is still connected to the bolt of the A/C compressor mounting bracket. The cable on the right is connected to frame ground at the horn bracket mounting bolt or further down and outside the engine bay at the driver's side front tow hook bracket.

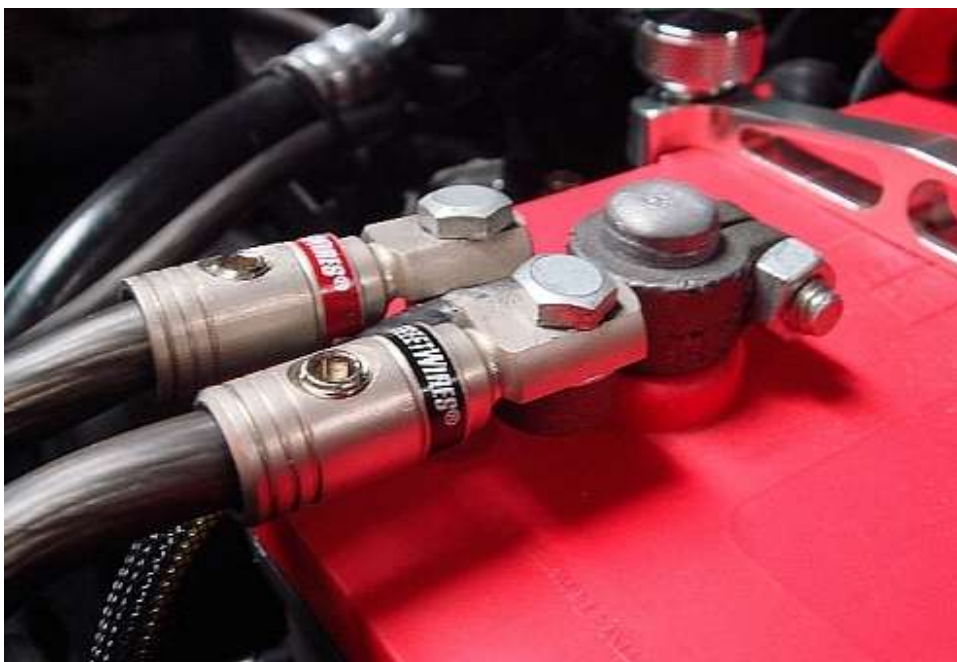
I used a different type of connector, **4 gauge StreetWires Power Rings**, for these wires to increase electrical conductivity, as well as provide a stronger connection. Just one connection at the battery post to totally disconnect power.

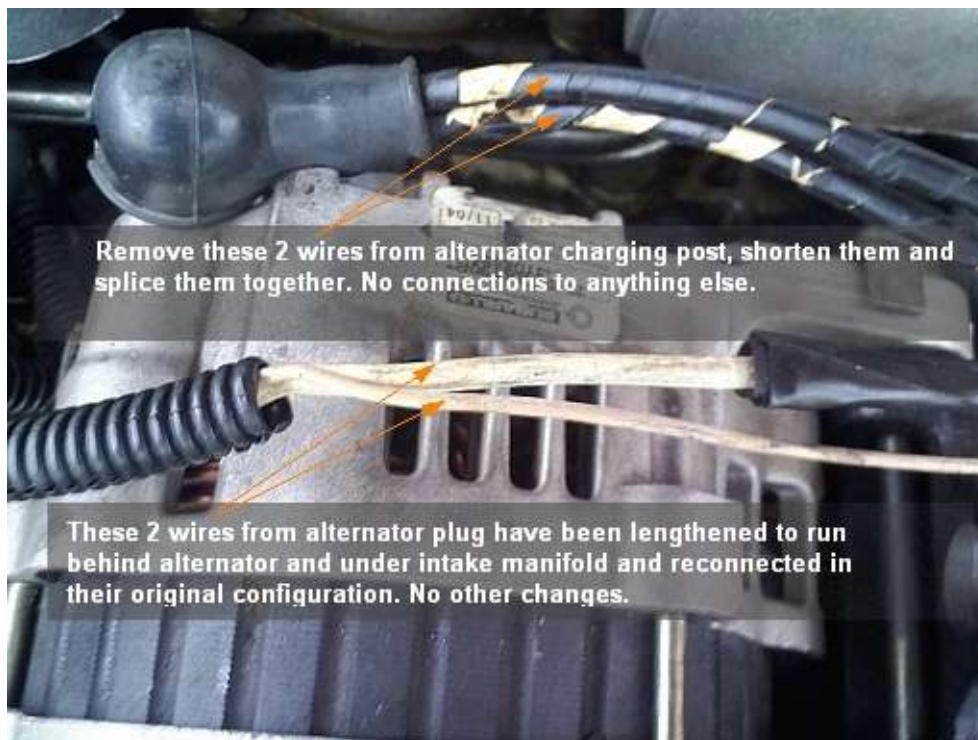
The plastic wiring channel which runs along the top of the engine in front of the intake manifold was opened. Inside the channel you will find two white wires with ring terminals attached to the alternator charging post. You will also find that the 2 white wires from the alternator plug on the side of the alternator runs through this channel as well. One is thicker than the other. More on that later

The following photograph is not of my car. It was taken at to show what the stock configuration of the Subaru SVX looks like before any modifications have been done. This is what is inside that plastic channel.

I removed the two white wires from the alternator post, cut off the ring terminals and shortened them almost 2 feet. One of these wires was factory-spliced into three wires close to the battery. Splice both of the white wires together, using solder or crimp connectors, protected with shrink-wrap tubing and electrical splicing tape.

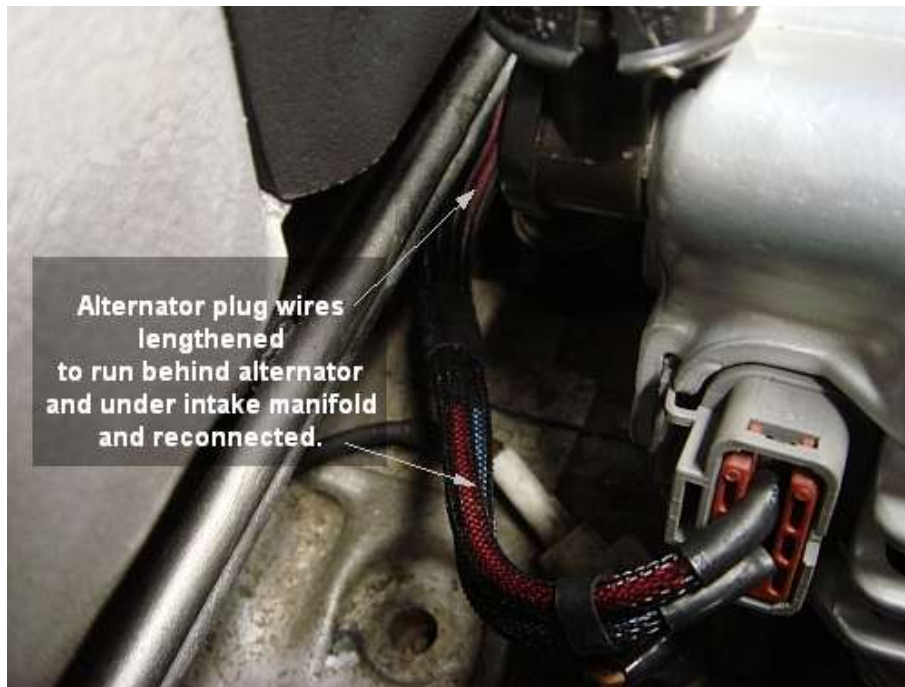
The alternator plug wires were removed from the plastic channel and cut. Be sure to remember which wires are which when you add an additional length of wire to each. You can do this by doing one wire at a time. Using a longer length of wire allows you to run the wires behind the alternator and under the intake manifold and be reconnected at their original position by the battery. These wires were soldered and shrink-wrapped and encased in heat-resistant nylon expandable braided sleeving.

The same lengthening procedure was done to the two small A/C connector wires, which entered the plastic channel by the A/C compressor. These run under the intake manifold as well and are also protected with the same heat-resistant braided sleeving. They are hidden out of sight for a clean look.

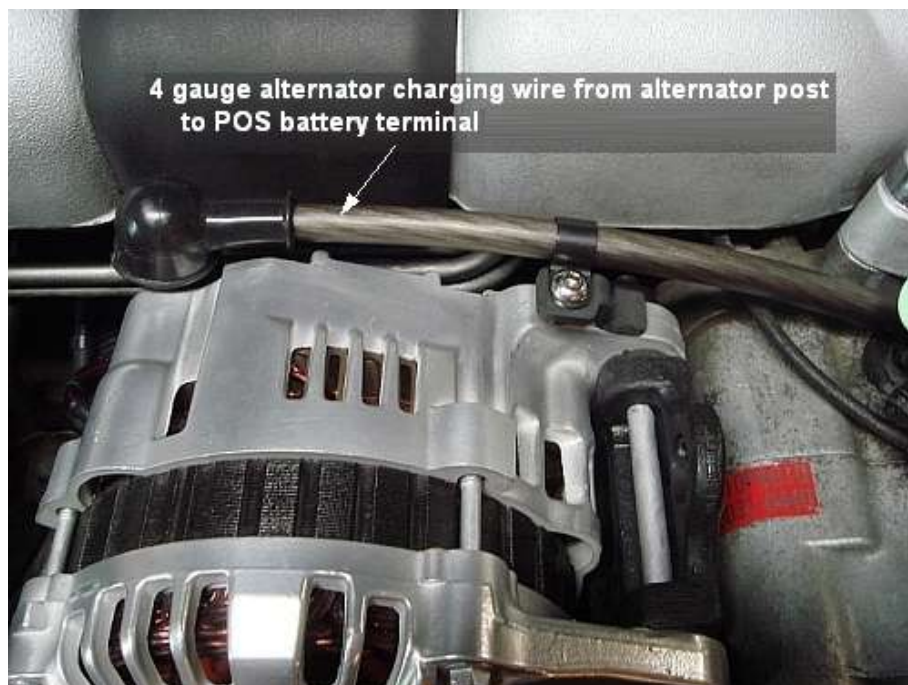
So all that remains is one single 4-gauge power wire, which runs across the top of the engine from the alternator charging lug to the positive battery post,

This single 4 gauge power wire replaces both of the original white wires originally at the alternator; one of which the original charging wire with the fusible link protection. With the two original wires disconnected from the alternator and connected only to each other, the fusible link protection remains in the circuit.

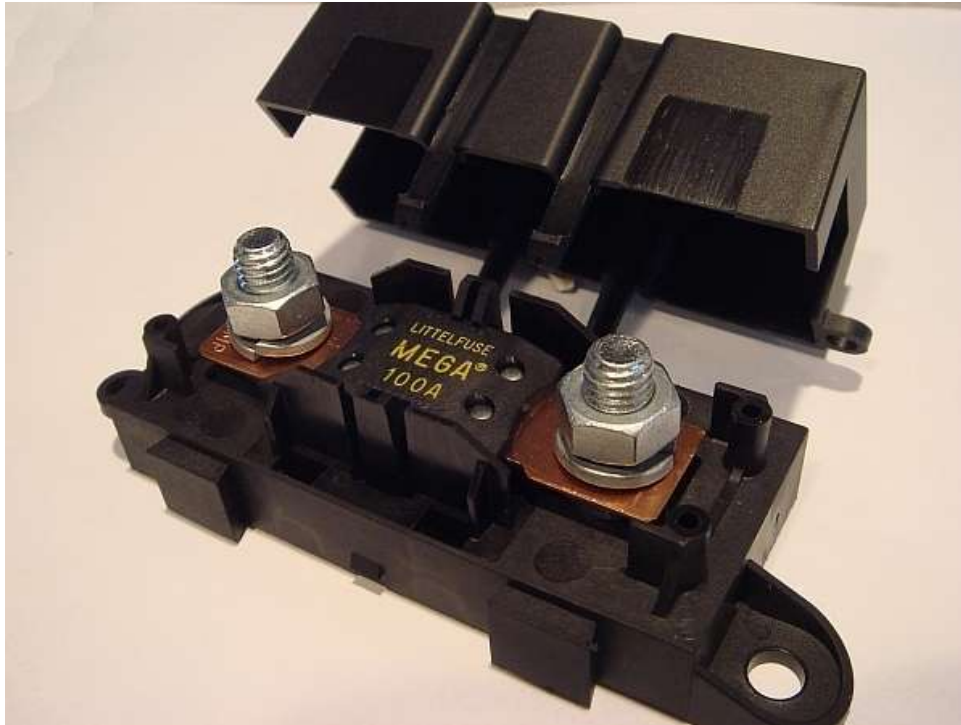
Although not necessary, additional protection is provided by a 175A Mega-Fuse. This installed as close to the battery as possible. In the event of an electrical problem, such as a short in the power wire, the fuse would blow and interrupt the circuit. If the voltage regulator in the alternator were ever to fail, the fuse would blow before damage to the electrical system could occur.

These are slo-blo fuses and will not fail during momentary high amp draw. As further testing occurs I may lower the amp rating of the fuse to 150A, 125A or 100A as needed.

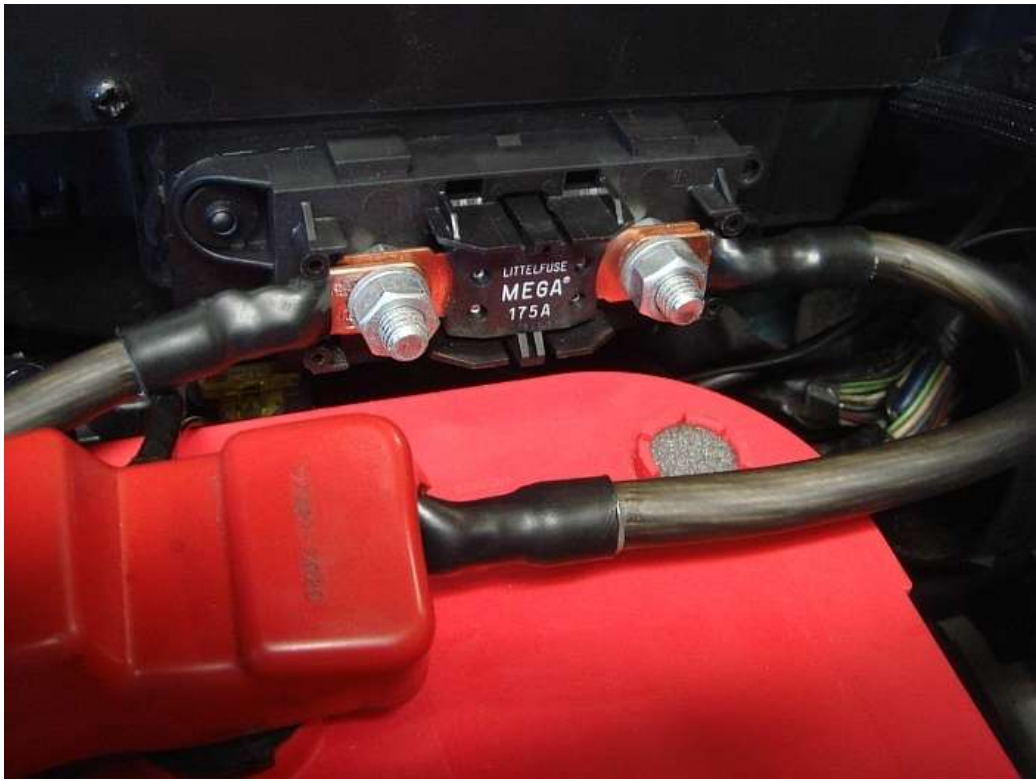
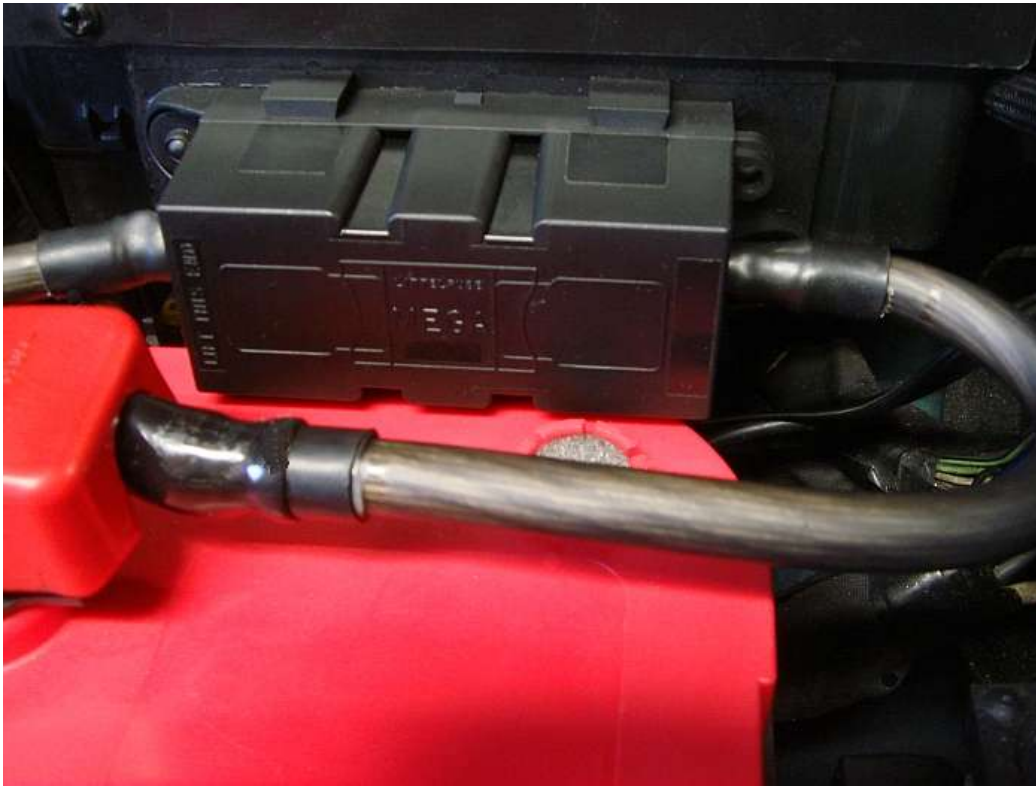
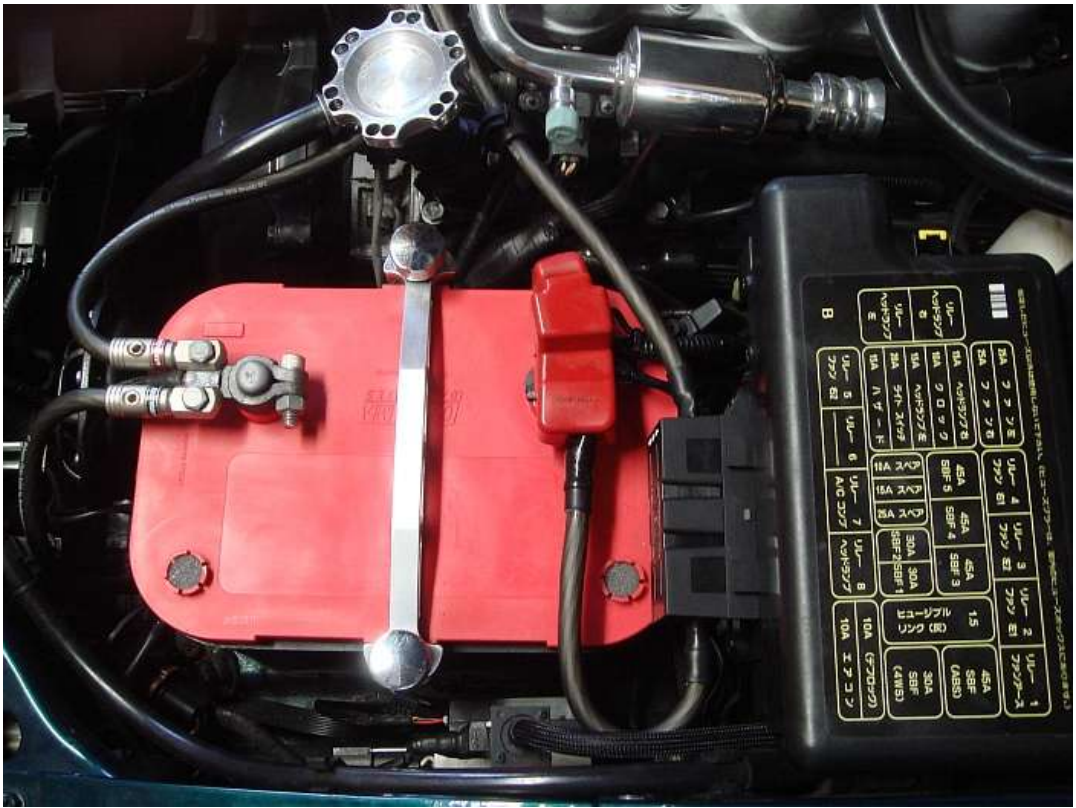
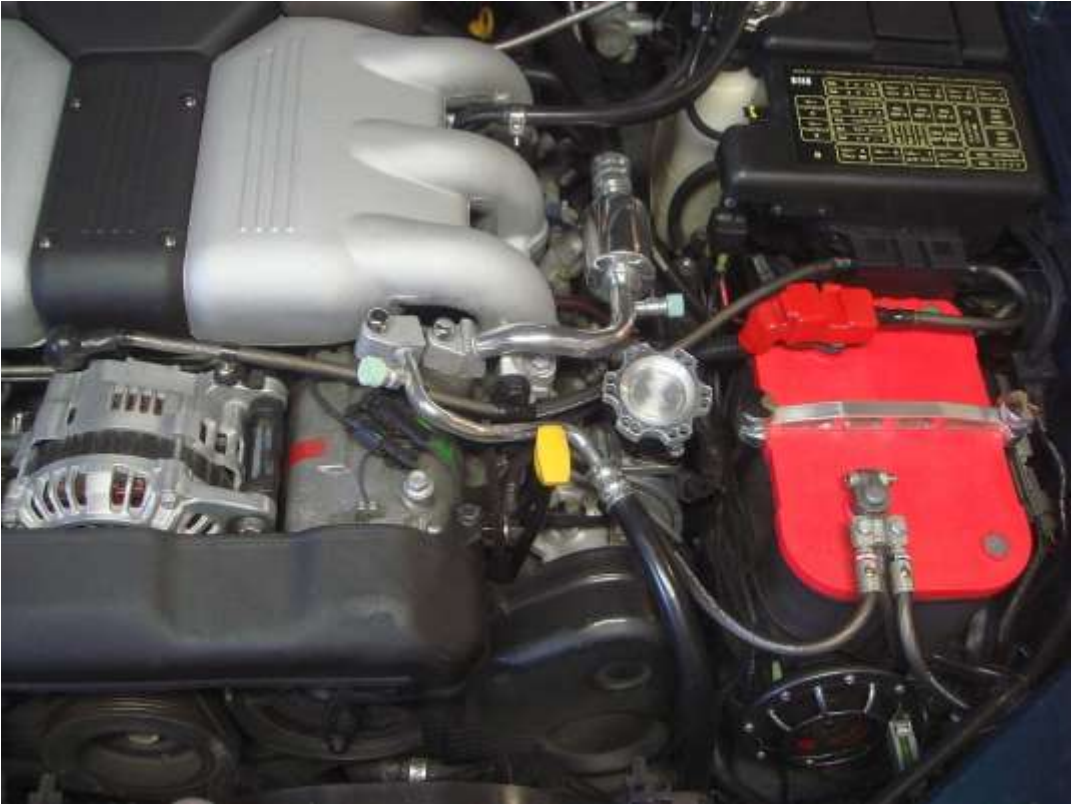
The following photos are a circuit overview of the entire wiring modification of the alternator wiring upgrade and fuse protection. It has been designed for a minimum of connections, with maximum transfer of current.

All connectors have been crimped, soldered, and sealed with heat-shrink tubing. Wire splices have been either soldered and shrink-wrapped, or use butt connectors which were crimped and covered with shrink wrap.

Electrical connections use a thin dielectric grease coating for corrosion protection.

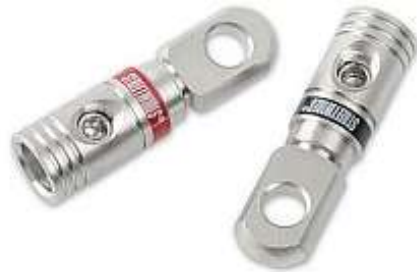
The battery ground wire terminals in my modification are **StreetWires 4 gauge set-screw Power Rings** are available from Crutchfield.com These run about **\$20.00 for the pair**, plus shipping.

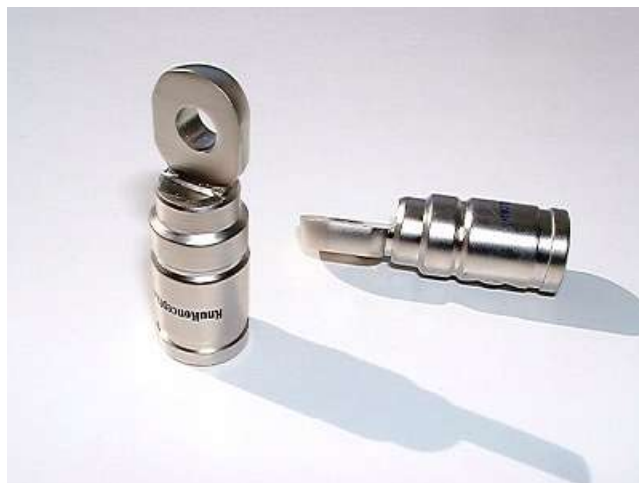
Alternative battery ground wire set-screw terminals by KnuKonceptz can be found on ebay [HERE](#) for about **\$10.00 per pair shipped**. Ship them with the power/ ground wires and save.

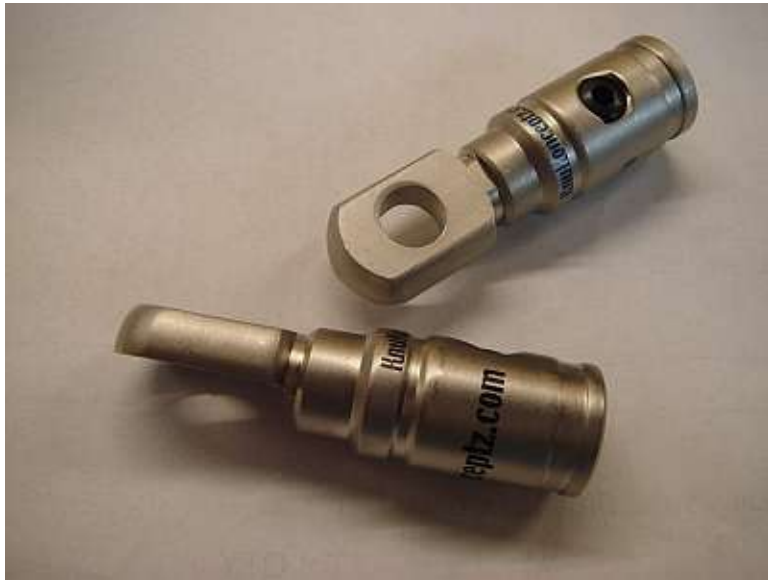
These are probably as good as the Streetwire PowerLock. I ordered a set with my new cables to compare. The only difference is the size of the Allen set screw. A close of photo is below.

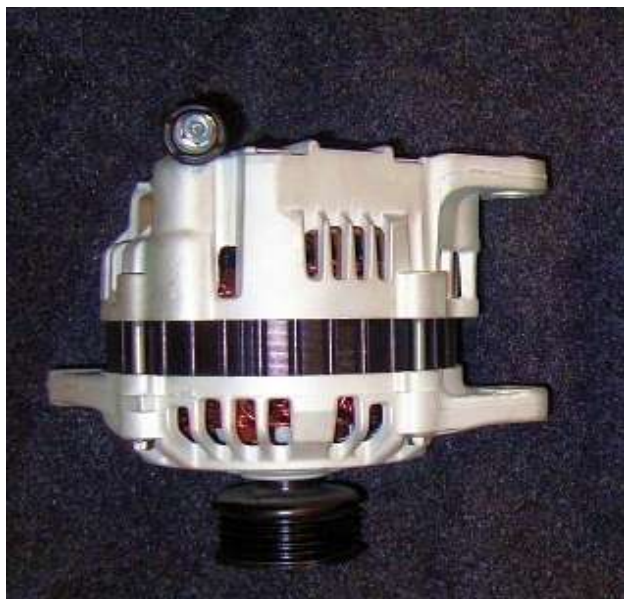
Now the heart of this system HAS to be the 160A high-output alternator, available from [Maniac Electric Motors](#). This is a top-notch rebuild which exceeds the factory unit in every way and is only \$188.00 after your core is returned.
